# ROUTINE INSPECTION REPORT

**Property:** 42 Willowbrook Drive, Karori, Wellington  
**Tenant(s):** Alice Johnson, Bob Johnson  
**Inspection date:** 2026-10-02  
**Completed at:** 2 Oct 2026 2:30pm  
**Landlord / Agent:** Demo Landlord

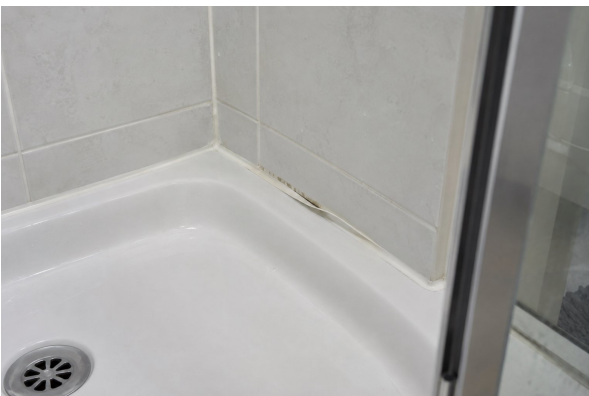
### Bathroom - Shower

Poor

Shower seal is lifting and moisture is getting behind it. Repair assigned to the plumber.

### Bathroom - Shower: Request assigned

Shower seal is lifting and moisture is getting behind it. Repair assigned to the plumber.

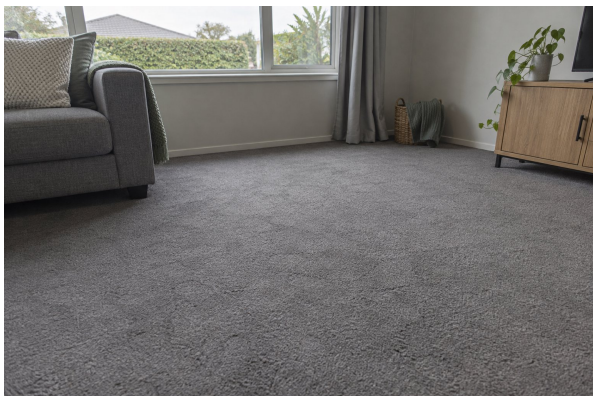
### Lounge - Carpet

Good

Carpet is clean with ordinary wear only.
